WE BRING WORN-OUT ROTARY VALVES BACK TO LIFE

The Rotary Valve shown in the following photos was not originally manufactured by Young Industries. The user selected Young Industries to refurbish the valve to new condition with some additional features to increase service life.

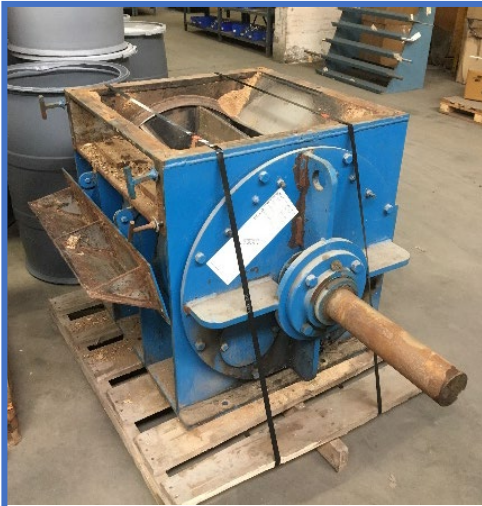
25" x 30" Rotary Valve not manufactured by Young Industries, but in need of repair

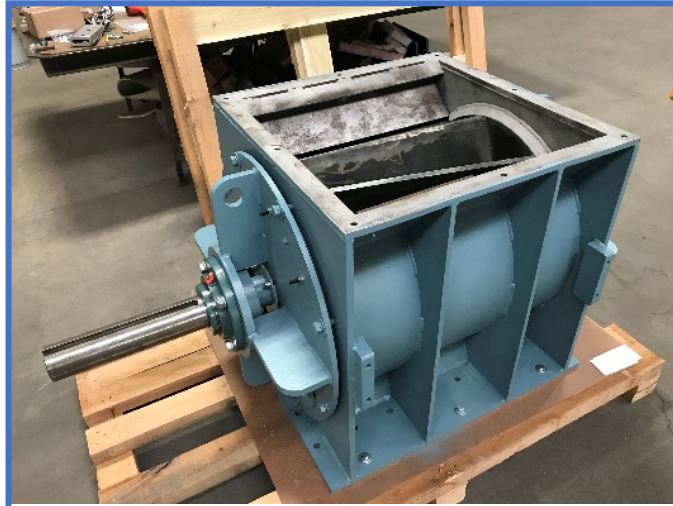
25" x 30" Rotary Valve repaired and upgraded to "better than new" condition

The completed rotary valve now has close internal clearances on all machined parts, and any worn pieces are repaired or replaced. This Rotary Valve was revived from the junk pile to as new condition with significant up-grades at a cost that was much less than purchasing a new rotary valve.

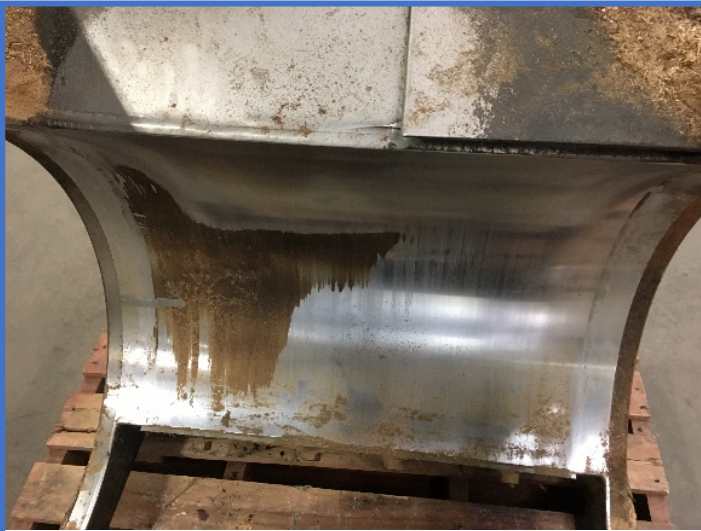
Hard chrome plated bore worn and grooved

The Rotary Valve was completely dis-assembled, cleaned, and all parts checked dimensionally and evaluated for surface wear. It was determined the valve could be repaired and additional features added to the valve to increase service life. These features include a Tungsten carbide coated housing bore and Stellite inlay on the rotor tips. The costs for refurbishing with the new features was presented to the user and they elected to proceed.

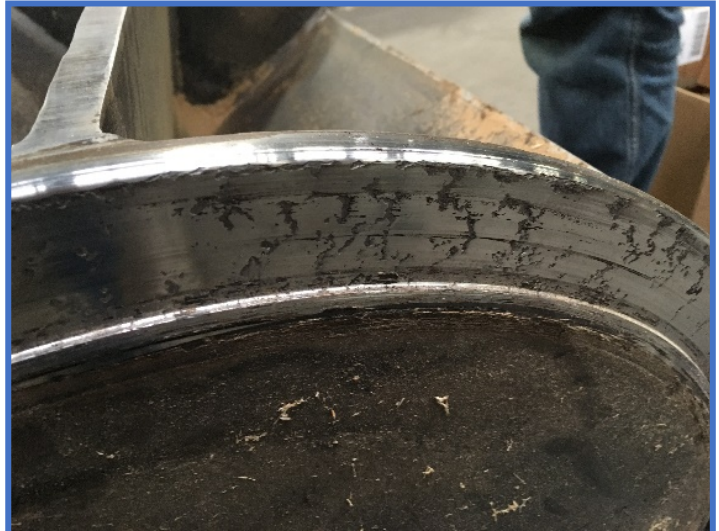
Extreme wear on shrouds

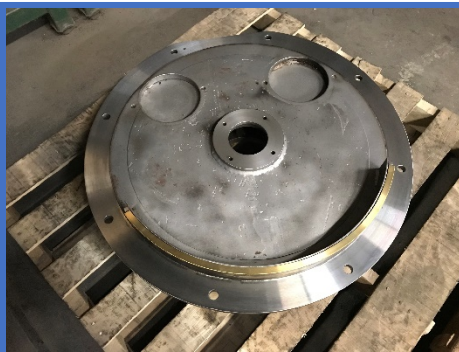
End plate after modifications

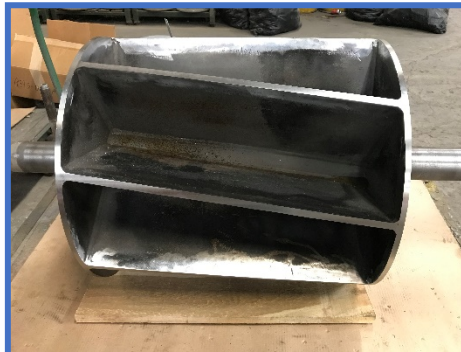
Modified rotor with stellite on tips and shrouds

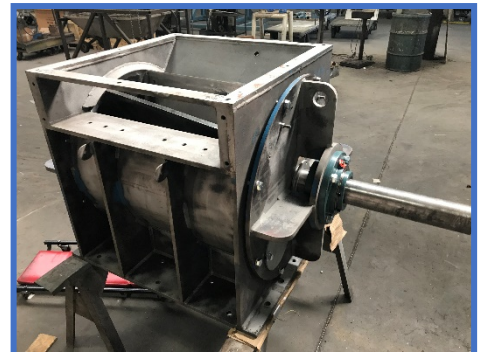
Valve being assembled

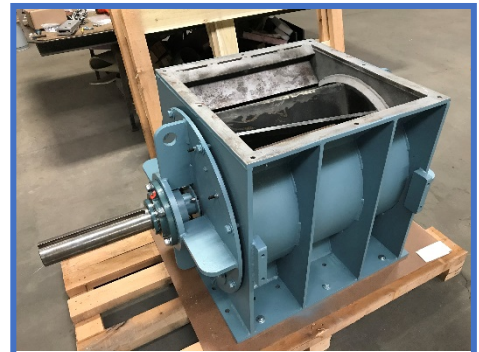
Completed valve fully assembled
