# PRODUCT LINE REPORT

## REFURBISHED ROTARY VALVE

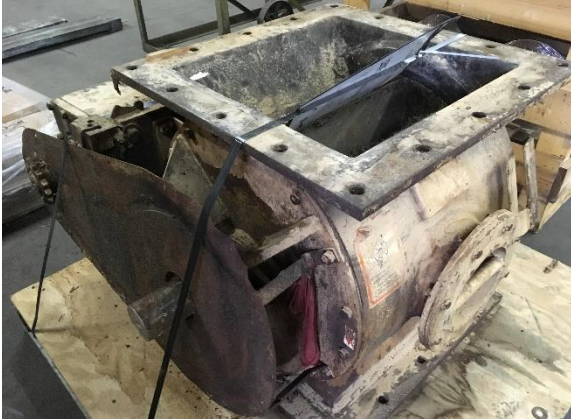
Rotary Valve as received from customer

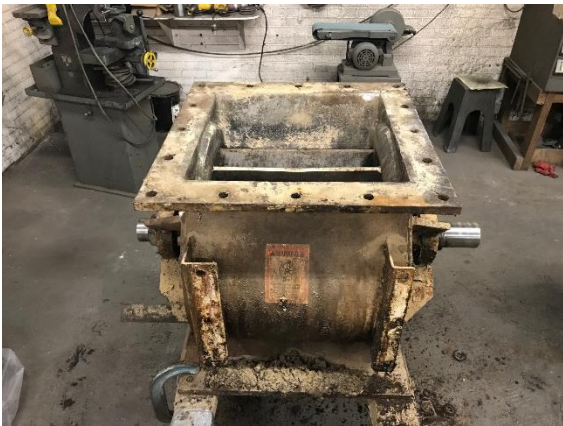
Rotary Valve with drive removed

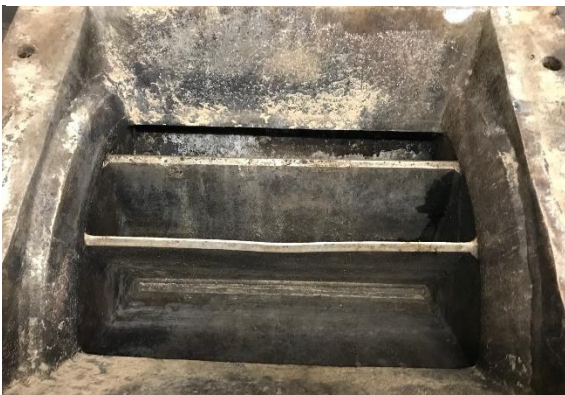
View of the rotor (note bent blade)

- a. Rotor blades were bent and worn. A new rotor was needed.
- b. Valve bore was worn in spots and would require machining to bring back to being round.
- c. The end plates required new Stellite hard surfacing and re-machining to match the new bore diameter of the housing
- d. The housing had some weld repair needed and machining of the inlet and discharge flanges.
- e. New bearings and seals would be needed.
- f. The Gearmotor ran smoothly and would be re-used
- g. The Roller Chain Drive and components would be replaced with new components.
- h. The Chain guard was missing and was replaced.

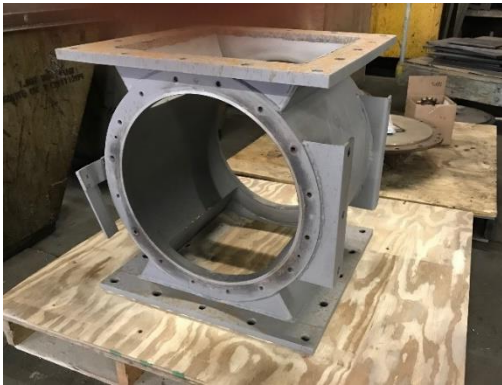
Rotary Valve housing after bead blasting

It was determined that the rotary valve could successfully be re-worked to bring back to new condition and maintain internal close clearances to comply with NFPA 69 regulations. Once the rotary valve bore was machined to get into proper tolerance for being concentric, the end plate and rotor dimensions were finalized. The end plates were machined and resurfaced to new condition. A new rotor was manufactured due to wear on the blades and shaft. The 20" Model LH Rotary Valve originally manufactured in 1990 was refurbished in 2017 and resulted in a big cost savings to our customer.

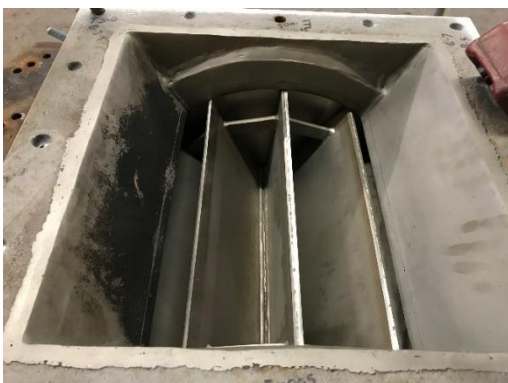
Inlet view of valve with new rotor installed
